# Lessons Learned and Case Study

Brownfield Cleanup Program

Michele Wittman  
Hazard Evaluations Inc.

# Case Study – 2017 Project, Buffalo, NY

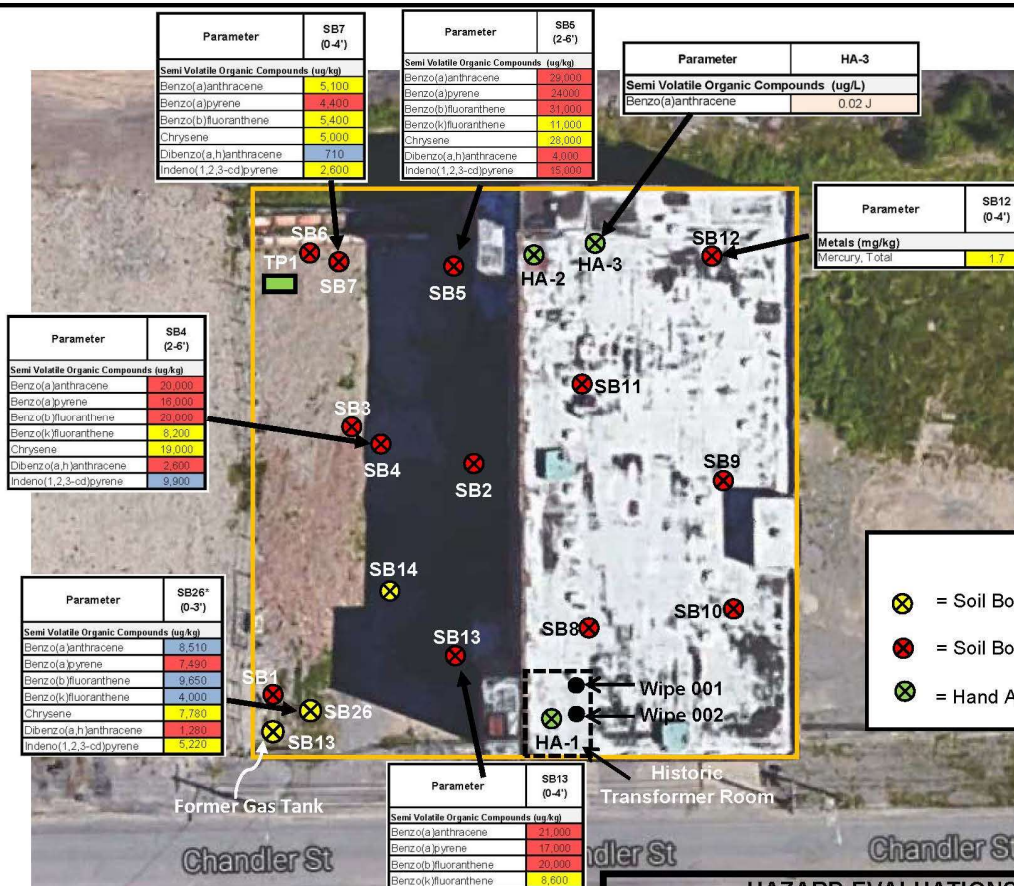
DRAWN BY: LSH	SCALE: NOT TO SCALE	PROJECT: e1608
CHECKED BY: EB	DATE: 01/17	FIGURE NO: III-A

Parameter	SB7 (0-4')
<b>Semi Volatile Organic Compounds (ug/kg)</b>	
Benzo(a)anthracene	5,190
Benzo(a)pyrene	4,490
Benzo(b)fluoranthene	5,400
Chrysene	5,000
Dibenzo(a,h)anthracene	710
Indeno(1,2,3-cd)pyrene	2,600

Parameter	SB5 (2-6')
<b>Semi Volatile Organic Compounds (ug/kg)</b>	
Benzo(a)anthracene	29,000
Benzo(a)pyrene	24,000
Benzo(b)fluoranthene	31,000
Benzo(k)fluoranthene	11,000
Chrysene	28,000
Dibenzo(a,h)anthracene	4,000
Indeno(1,2,3-cd)pyrene	15,000

Parameter	HA-3
<b>Semi Volatile Organic Compounds (ug/L)</b>	
Benzo(a)anthracene	0.02 J

Parameter	SB12 (0-4')
<b>Metals (mg/kg)</b>	
Mercury, Total	1.7

Parameter	SB4 (2-6')
<b>Semi Volatile Organic Compounds (ug/kg)</b>	
Benzo(a)anthracene	20,000
Benzo(a)pyrene	16,000
Benzo(b)fluoranthene	20,000
Benzo(k)fluoranthene	8,200
Chrysene	19,000
Dibenzo(a,h)anthracene	2,600
Indeno(1,2,3-cd)pyrene	9,900

Parameter	SB26* (0-3')
<b>Semi Volatile Organic Compounds (ug/kg)</b>	
Benzo(a)anthracene	3,510
Benzo(a)pyrene	7,490
Benzo(b)fluoranthene	9,650
Benzo(k)fluoranthene	4,000
Chrysene	7,780
Dibenzo(a,h)anthracene	1,280
Indeno(1,2,3-cd)pyrene	5,220

Parameter	SB13 (0-4')
<b>Semi Volatile Organic Compounds (ug/kg)</b>	
Benzo(a)anthracene	21,000
Benzo(a)pyrene	17,000
Benzo(b)fluoranthene	20,000
Benzo(k)fluoranthene	8,600
Chrysene	19,000
Dibenzo(a,h)anthracene	2,400
Indeno(1,2,3-cd)pyrene	9,900

**SOIL BORING LOCATIONS**  
 166 CHANDLER STREET  
 BUFFALO, NEW YORK

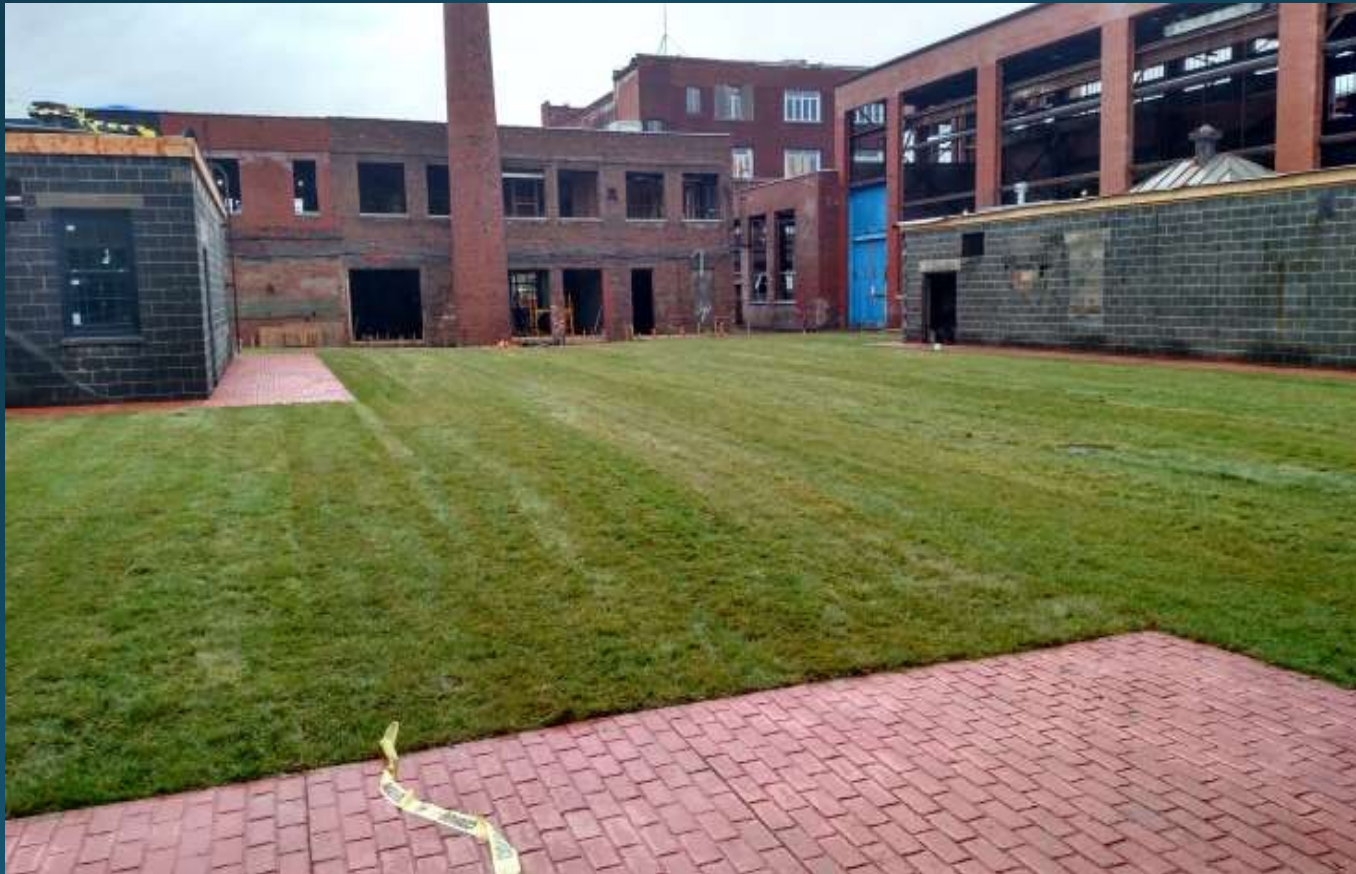
Courtyard –  
December  
2017

- Worked with ACM Contractor for Soil Removal
- ACM and PCB soil removed July 2017
- Courtyard Control not until August 2017
- Remove PCB soil over 50+ ppm
- Remove concrete footers and foundations
- Remove UST, drainage structures, and impacted fill
- Chimney Stabilization and Restoration Issues
- Confirmatory sample results confirmed no testing results above Restricted Residential numbers – End of October 2017

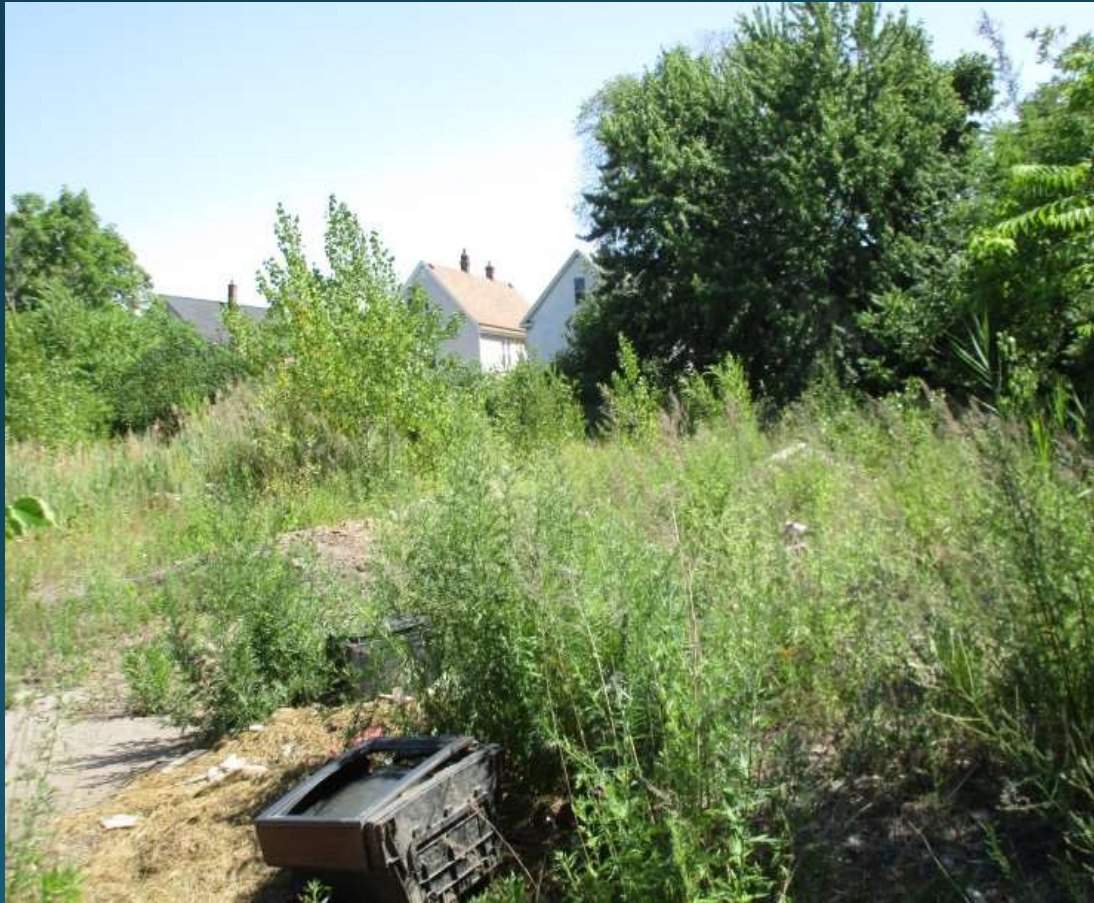
Parking Lot –  
July 2017

- Parking Lot area
  - Plan was simple - excavate to 3 to 4 feet
  - Identified hazardous levels of Lead – May 2017
  - Submittal of additional Work Plan for delineation of Lead
  - Submittal of Work Plan for Lead Stabilization
  - Work completed in September 2017
  - Excavation and confirmatory sample results confirmed no testing results above Restricted Residential numbers – End of September 2017
